WOODS HOLE OCEANOGRAPHIC INSTITUTION

A study of the bathymetry and sediments of  
the U. S. Navy Torpedo Range in  
Cape Cod Bay

Final Report

Submitted to the U. S. Naval Underwater Ordnance  
Station, Newport, Rhode Island  
Under Contract N298(122)16639 and  
Reqn. No. 122/5271/60  
July, 1960

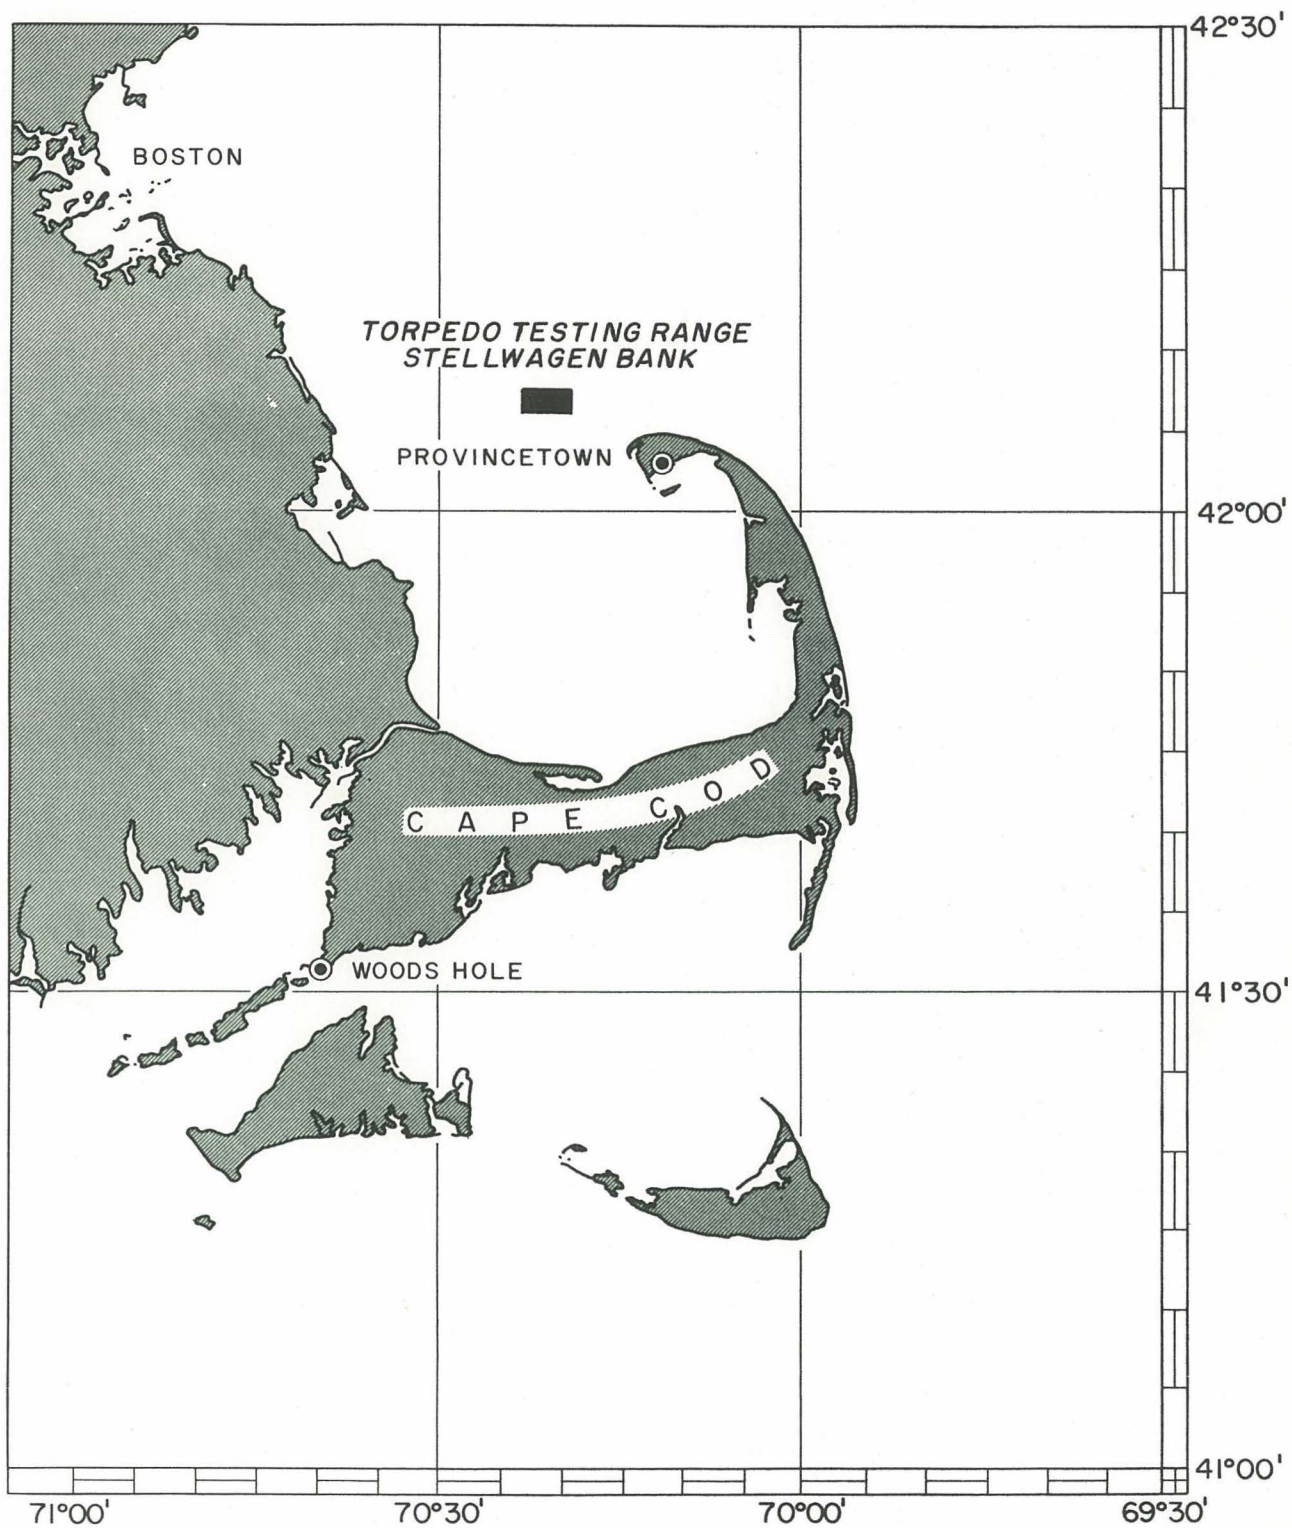
FIG. I

Index Map

The area is located about a mile south of Stellwagen Bank, hence outside the boundaries of the range one moves into shallower water rapidly on a traverse to the north. (Fig. 1).

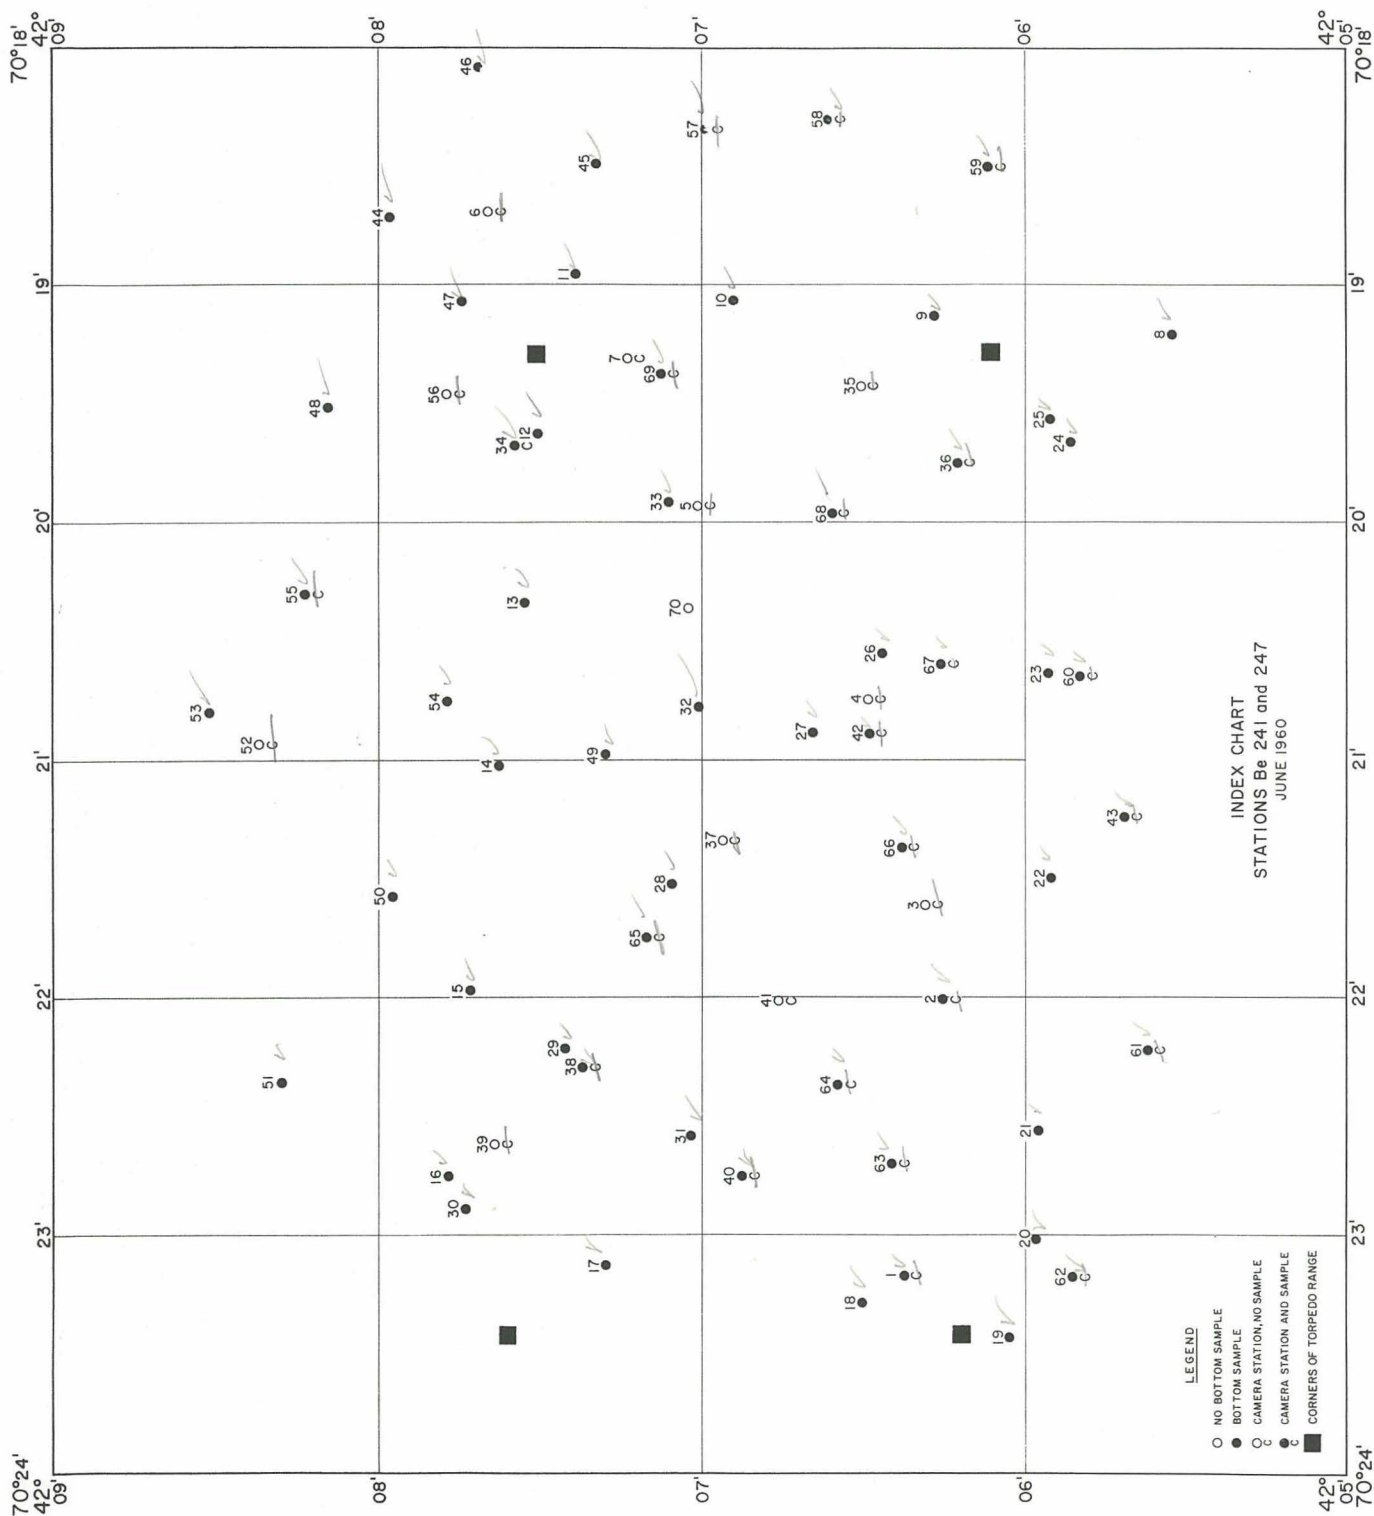
FIG. 2

Sediment samples were taken in and around the torpedo range (Fig. 2). Samples were collected by a Van Veen snapper dredge, by a coring device mounted on the underwater camera and by coring devices alone. The samples were analyzed for sand, silt, and clay (Table I). These terms indicate sediment size, not necessarily composition. Sand as used here is sediment larger than 0.062 mm. (held by No. 230 U. S. Standard sieve), silt is composed of particles between 0.062 mm and 0.0039 mm, while clay is material smaller than 0.0039 mm. The silt and clay percentages were determined by pipette analyses. The ratio of sand to silt-clay is also indicated in Table I.

Bottom photographs were taken at stations marked "C" on Figure 2. These photographs and a discussion of them appear in Appendix I of this report. Much of the discussion is repeated here for the benefit of those who do not have access to the actual photographs.

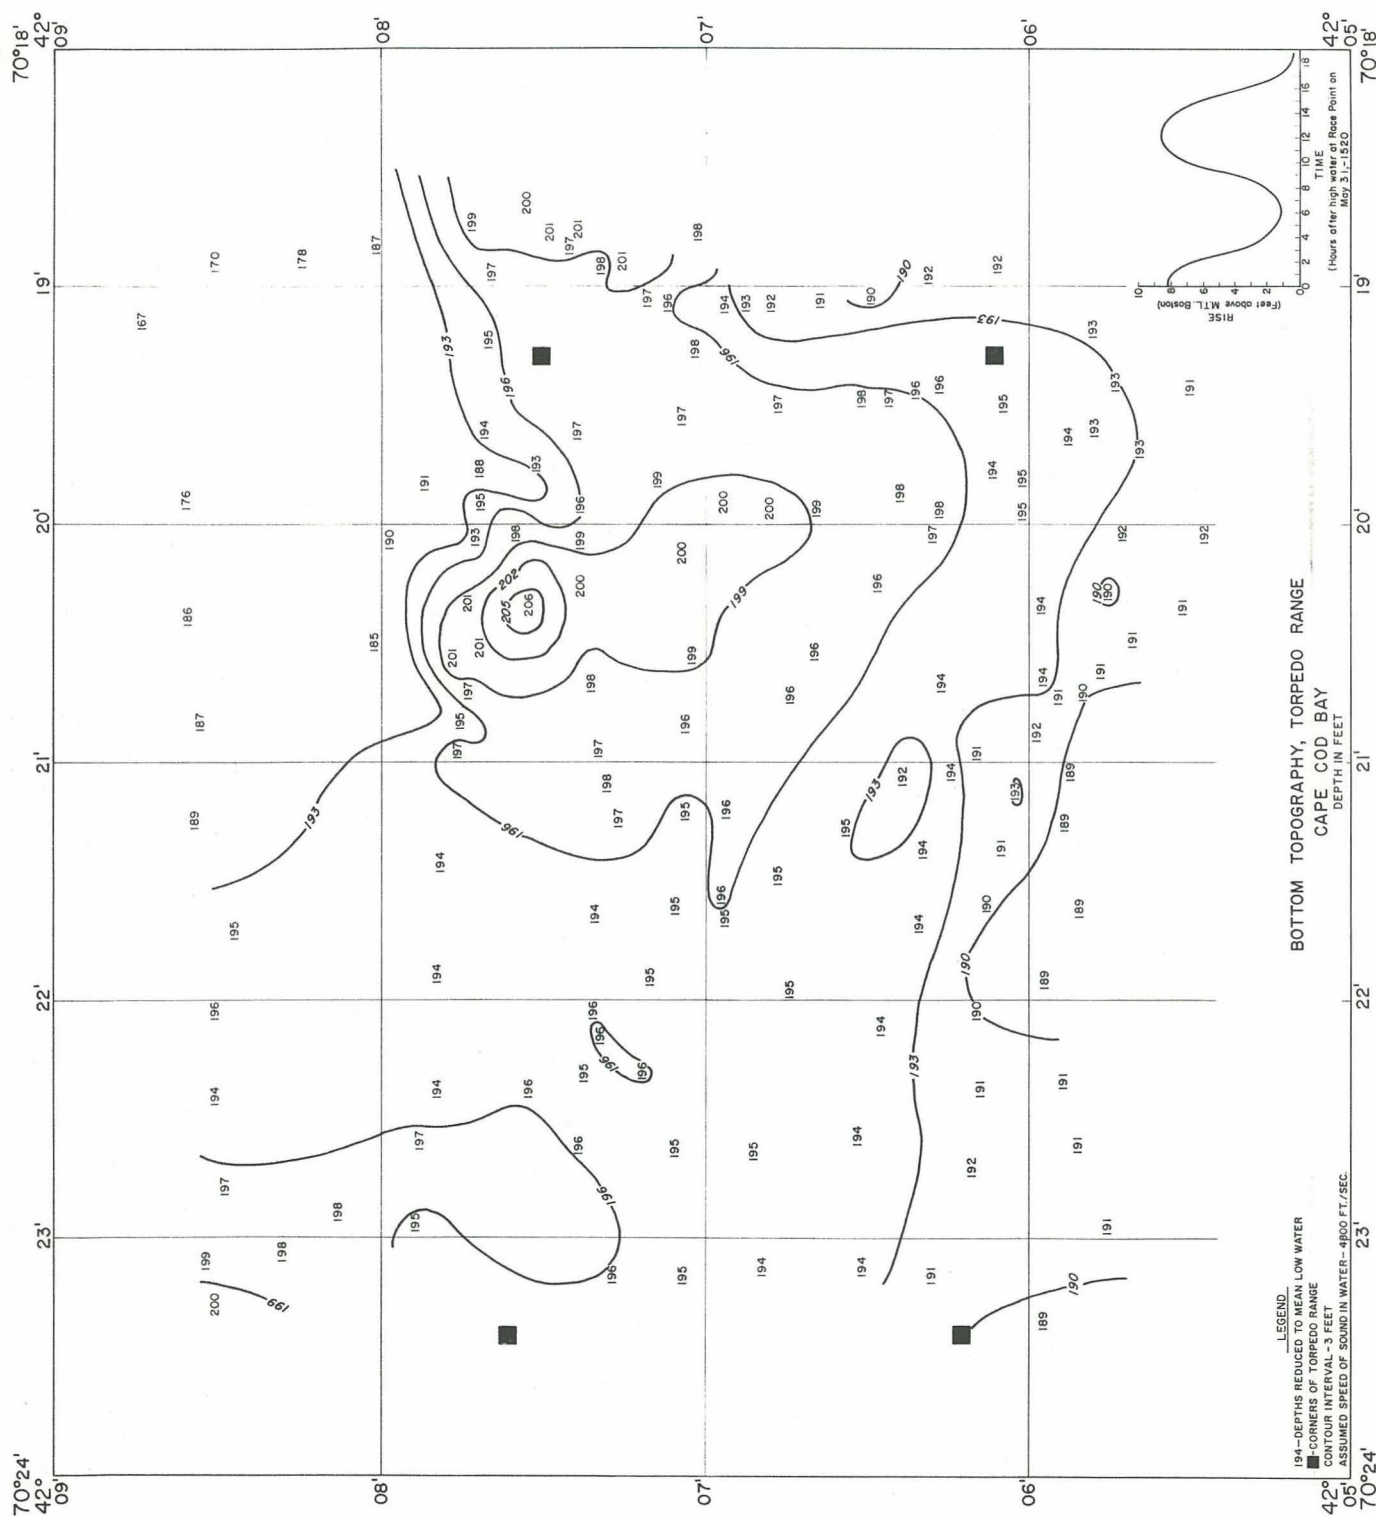
**FIG. 3**

Inside the target range the bottom is virtually flat. Figure 3 shows the detailed configuration of the bottom using a contour interval of three feet or one-half fathom. For all

Figure 3 was constructed by first plotting the depth of water at each station from the continuous recording echo sounder. Station locations were plotted and the contours drawn.

An appreciation of possible errors is useful for background information and should be considered if soundings at a specific spot become important. In general, it seems reasonable to say that the contoured appearance would not change very much from that presented on Figure 3 even if all errors were known and corrected.

The tidal range at Race Point, five miles away, is about nine feet, (C&GS, 1960). We found a decided influence on soundings with respect to the tide level within the torpedo range. All of the soundings on Figure 3 are reduced to mean low water as if the full nine foot range were effective. The effect in the target area probably is not so great as 9 feet, but this reduction does not introduce an absolute error greater than the desired precision. Computations for the theoretical rise of the sea surface were not attempted. Failure to apply the

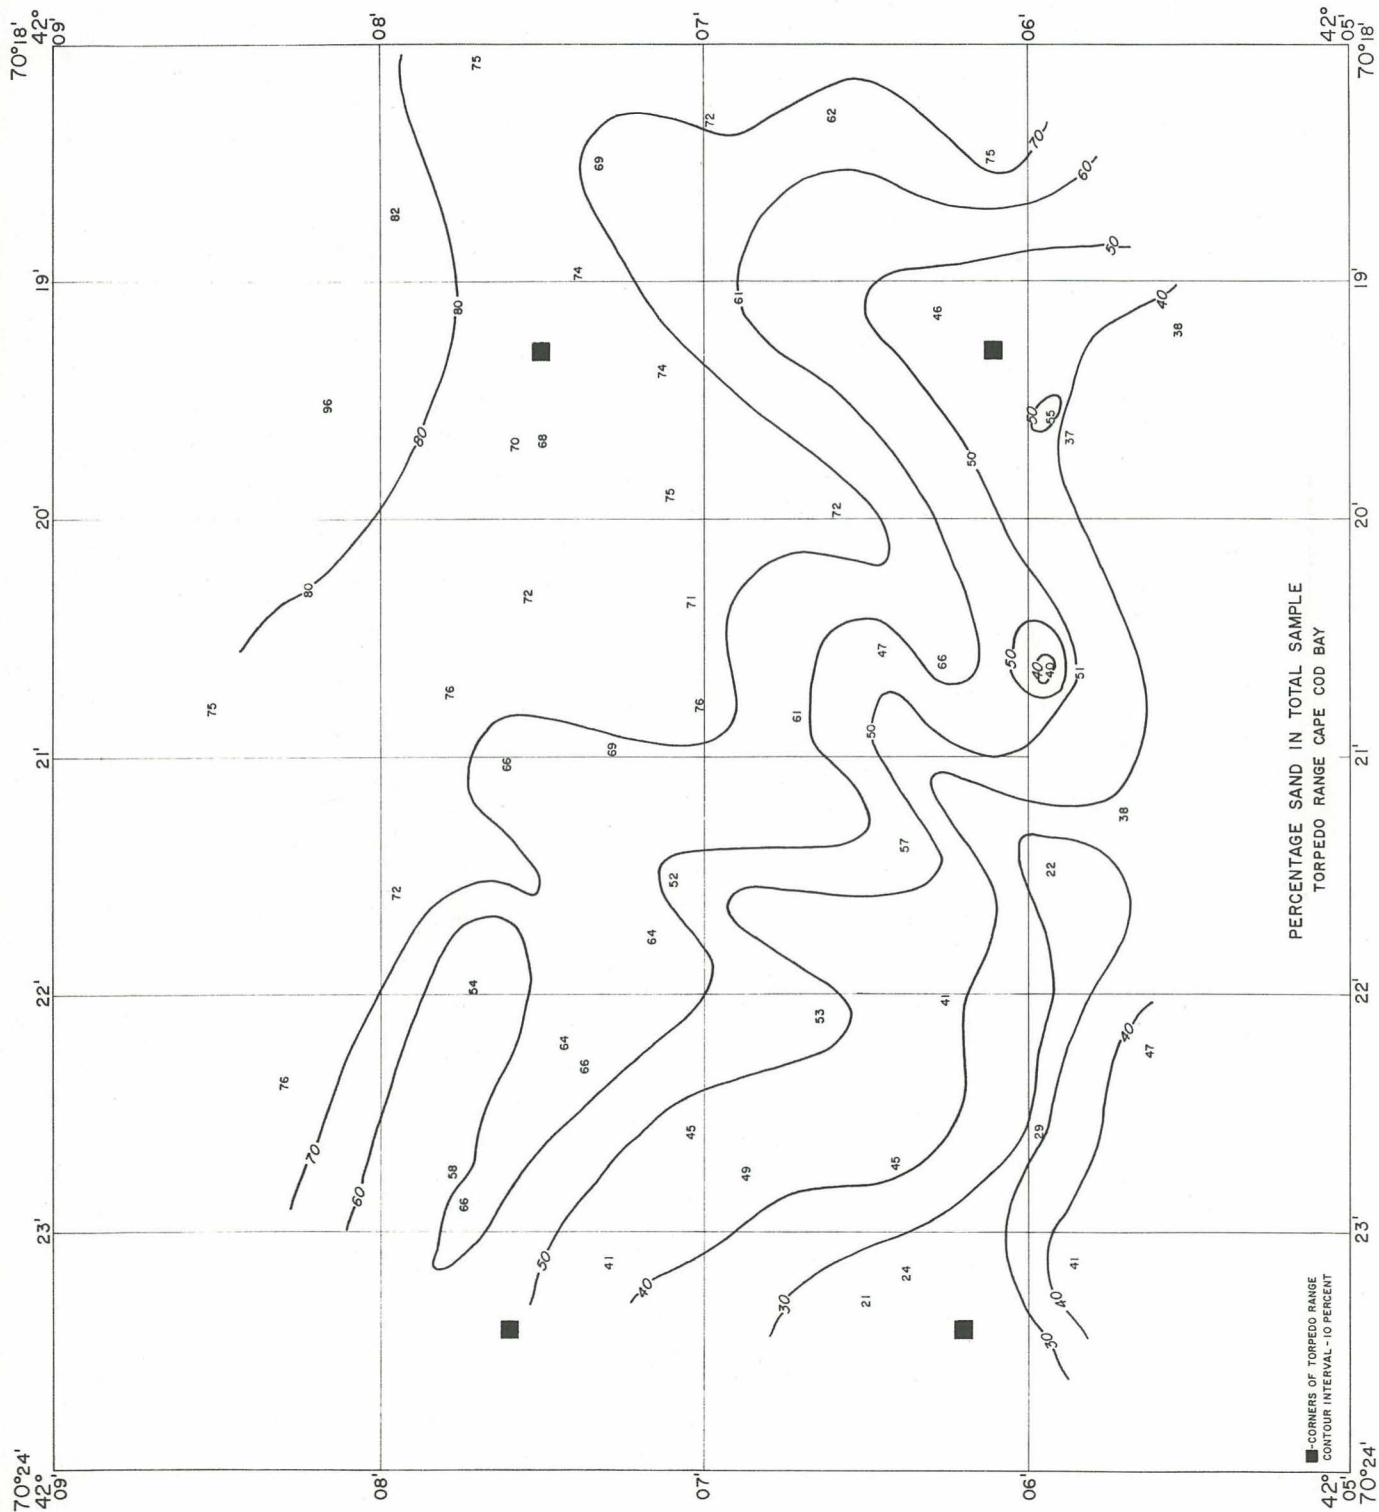
FIG. 4

The writers present the data in terms of the sand content (Figure 4) because: (1) This variable clearly shows the overall pattern of distribution, and (2) The bearing strength of the bottom material is related to sand content.

The sediments in the torpedo testing area can be classified as ranging from silty sands to sandy silts (Shepard and Moore, 1955). Such sediments have less than 20 per cent clay sized particles, from 75 to 25 per cent sand particles and 25 to 75 per cent silt sized particles. The distribution (Figure 4) clearly reflects the nearness of Stellwagen Bank, which is covered by sand and swept by strong currents.

The per cent sand in the sediment increases with surprising regularity from about 20 per cent in the southwest to 80 per cent in the northeast. Table II gives information regarding the size of the sand fraction along a traverse from southwest to northeast (from low sand content to high.) There is not apparent increase in median diameter or coarseness as sand content increases.

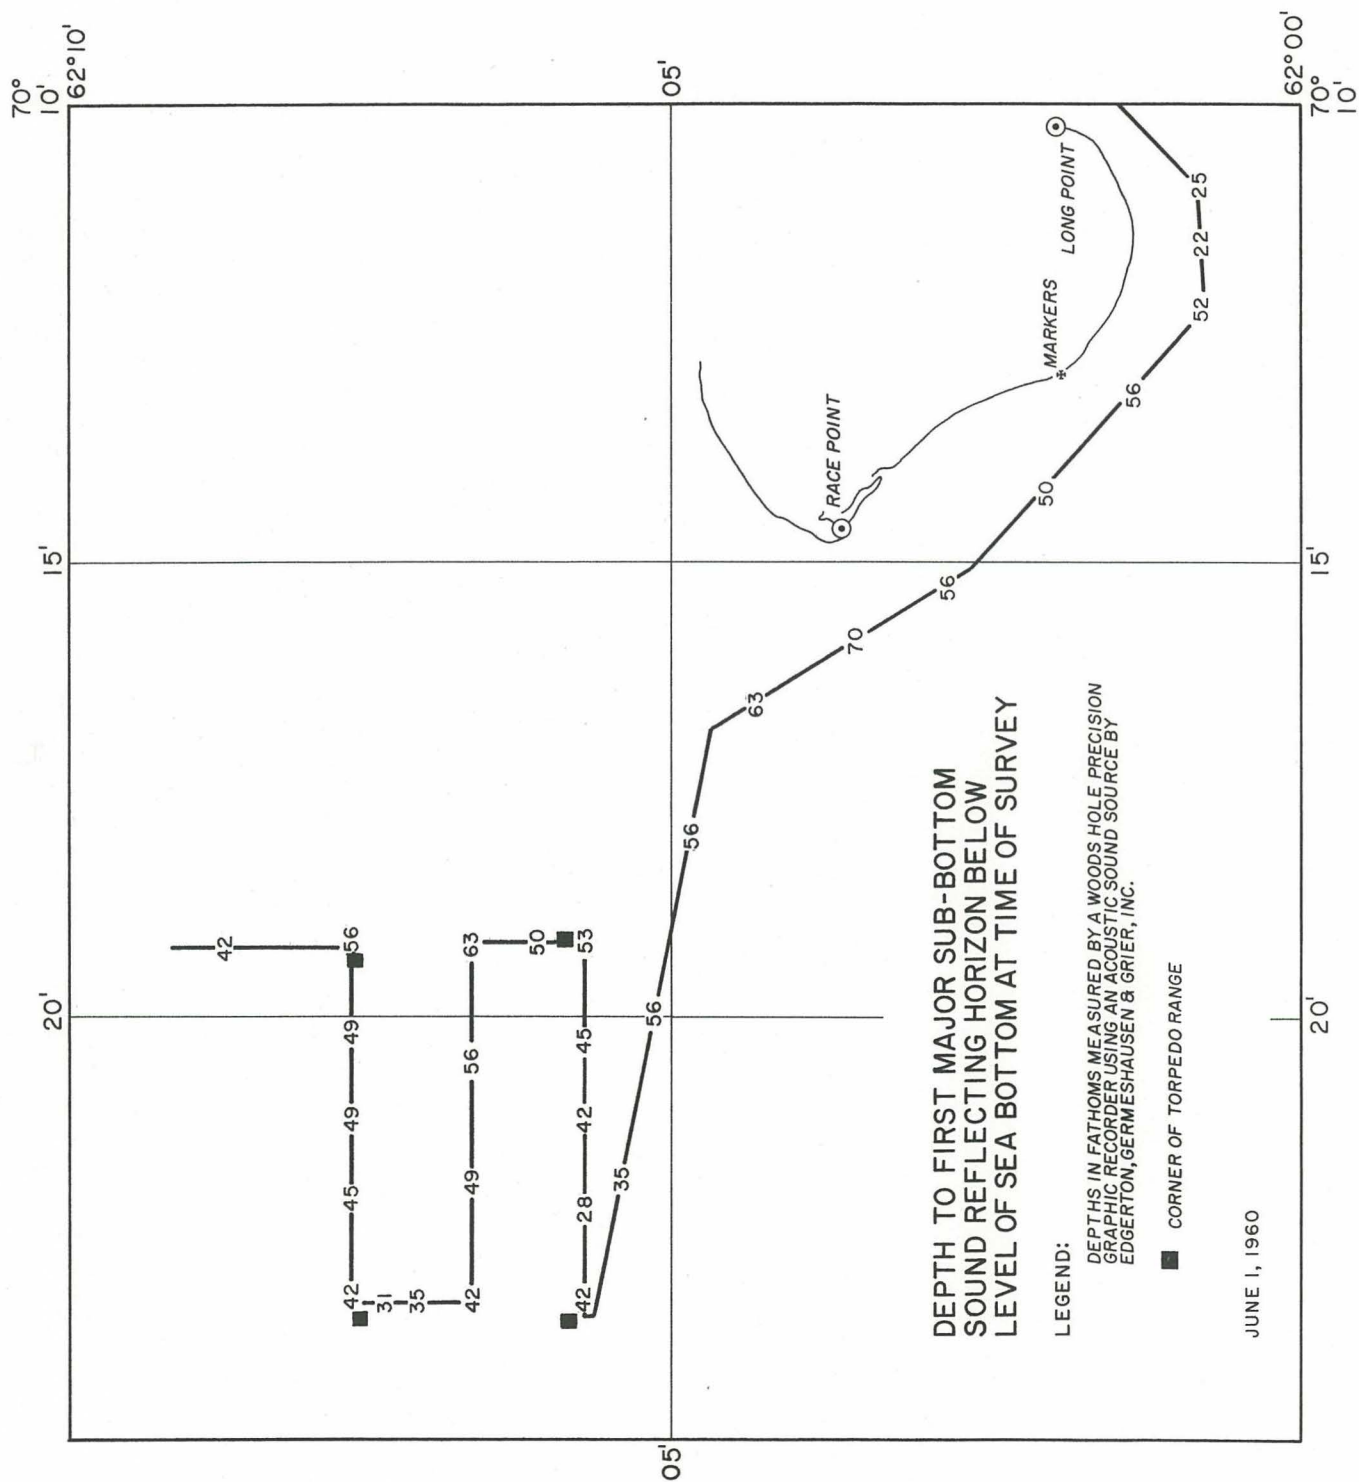
FIG. 5

Though it was not possible to examine the sub-bottom by collecting long cores we did use a sonic probe with the results given on Fig. 5. The numbers refer to the depth in feet to the first major reflecting horizon below the sea bottom probably crystalline basement (Hartley Hoskins, unpublished manuscript). Wells drilled near Provincetown penetrated both fluvio-glacial material (Woodworth and Wigglesworth, 1934) and Eocene sediments (Zeigler, Hoffmeister, Geise and Tasha, 1960). A reasonable guess based on this work is that the sea floor near the torpedo range is covered by 15 to 20 feet of marine sands and mud, 100 to 200 feet of glacial material and 100 (?) feet of Tertiary sediment overlying the crystalline basement.

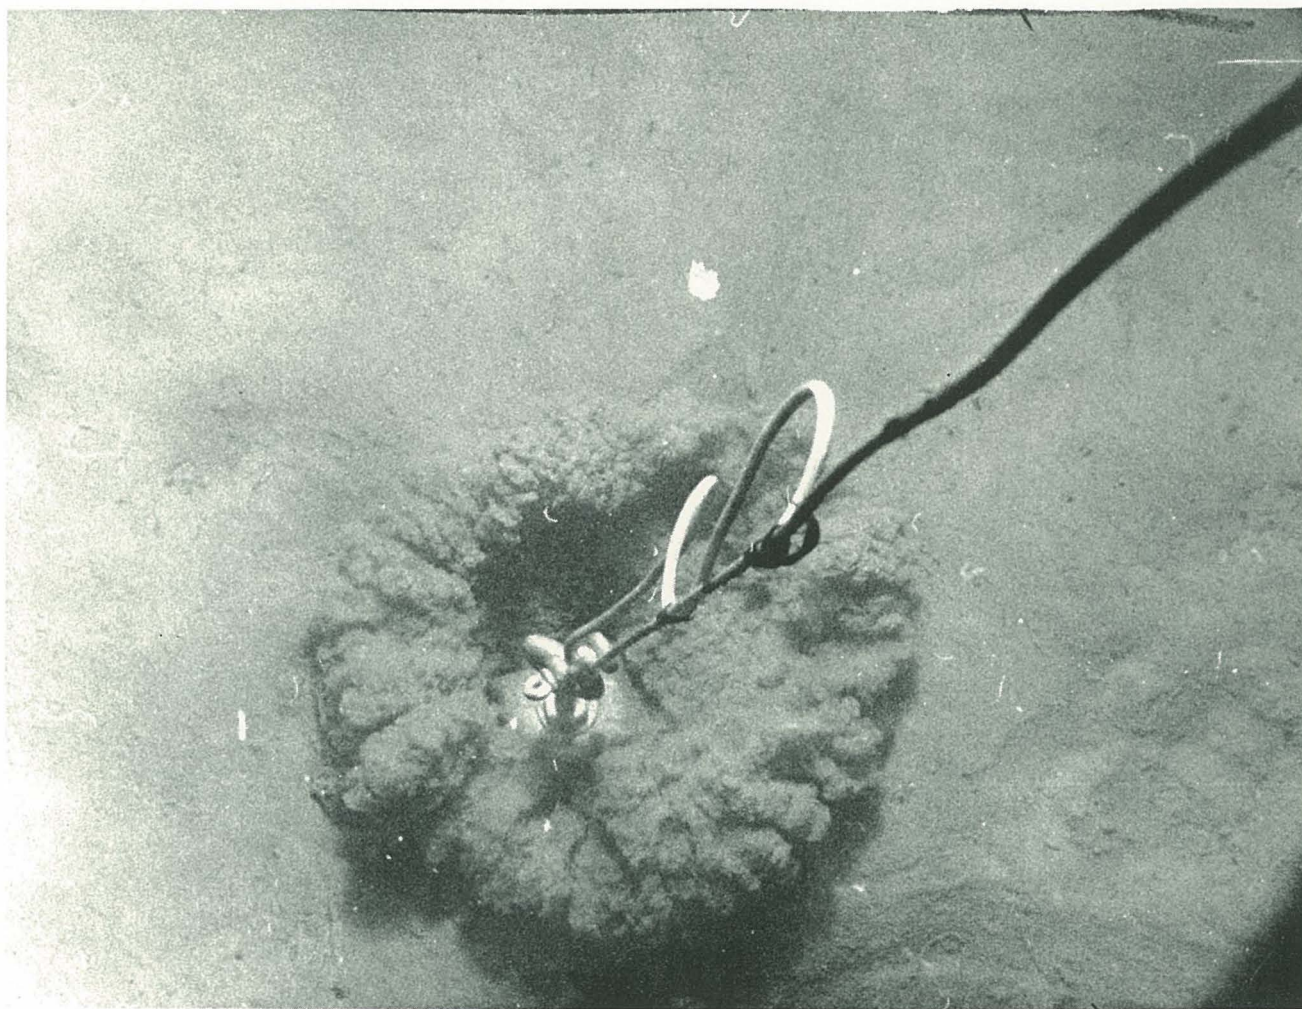
FIG.6

Bottom Photograph - Station 43

Copies of two representative bottom photographs (Figure 6 & 7) taken at stations 43 and 52 illustrate the difference between a sandy bottom and a muddy one. Station 43 is in an area where there was only 38 per cent sand. Station 52 has about 80 per cent sand. The difference discussed above can be seen here.

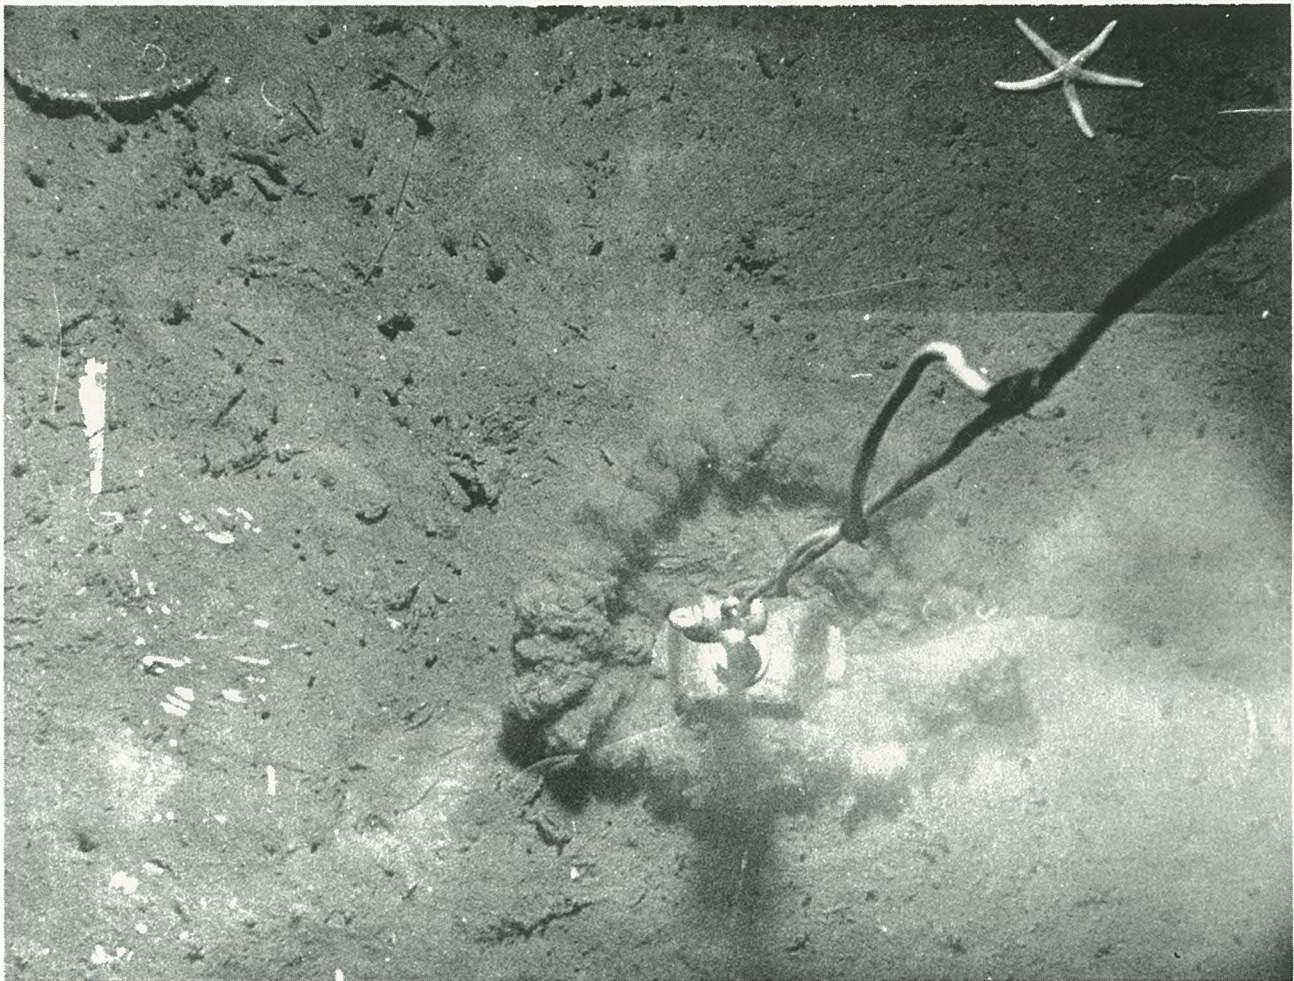
FIG. 7

Bottom Photograph - Station 52
